Vacuum Trucks Key to Successful Trench Rescue

Issue 9 and Volume 163.

BY STEVE WHITE

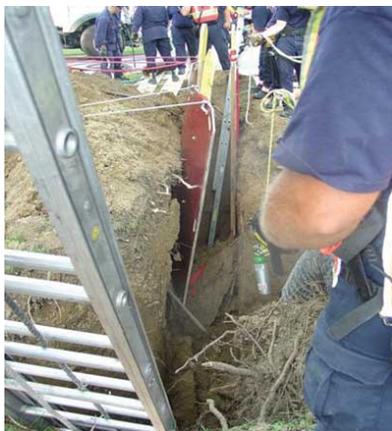
(1) The victim trapped in the V-void. [Photos by Division Chief Jim Alderman, Fishers (IN) Fire Department.]

The 35-year-old private contractor (the only victim) was attempting to tap a residential sewer line when he became trapped by a slough-in collapse. The only visible part of the victim was his right hand. A large section of clay that formed a V-void between the wall and the floor, which was partially supported by a shovel, covered his torso. The

remainder of his body was buried to the nipple line of his chest. The victim stated he was in the standing position.

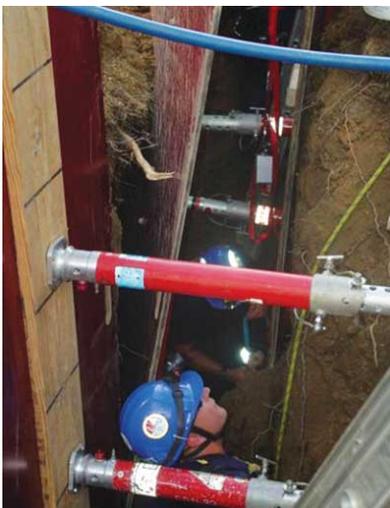
(2) A rescue medic starts

an IV in a protected area.

The first set of panels was set next to the victim because of the large section of soil covering him. Our smallest air shores were used to secure the first set of panels. From the first set of secured panels that created the initial safe zone, the FFD rescue medic conducted an assessment, obtained baseline vitals, and established an IV. The victim answered questions appropriately and complained of back and leg pain.

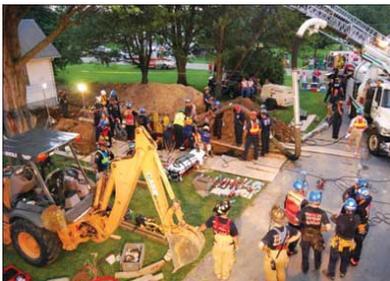
(3) HCTRT members
operate the rescue
vacuum system.

The city vacuum truck arrived, and members of the CFD assembled the vacuum system. The remainder of the trench lip was made safe with sections of the spoil pile removed by the rescue vacuum. HCTRT members supported a one-inch water line at one end of the trench. The second vacuum truck arrived and was staged as a backup.

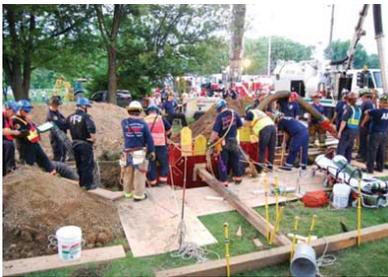
(4) The buttress system as part of the shoring plan.

Two additional panel sets were installed to gain working room. Since a section of the lip and the wall were missing, a buttress system was built to create a contact point behind one of the panels to ensure positive contact with the shoring system. The buttress was used in lieu of traditional “outside wales,” since the width of the trench was limited. Two 24-inch low-pressure air bags were used to take up void spaces between two separate panels and maintain positive contact in the shoring system.

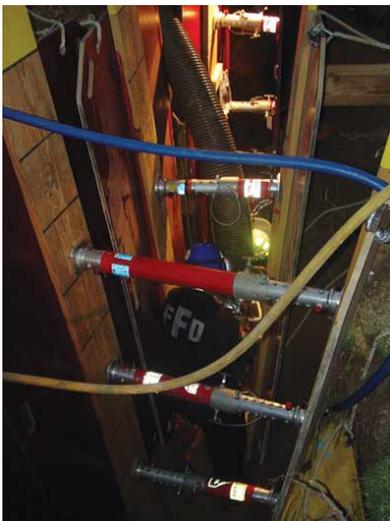
(5) The rescuers remove soil from the victim with the rescue vacuum and the air knife

A combination of folding shovels and an air knife was used to break up the soil to be removed by the rescue vacuum. Rescuers carefully removed the large section of clay positioned directly over the victim and creating the V-void. This section was estimated
